US Army Corps
of Engineers®

Huntington District

Today, Zoar Levee & Diversion Dam is a Dam Safety Action Classification I (DSAC I) Project, as progression toward failure may have begun. To remedy the risk the project has, the U.S. Army Corps of Engineers has implemented several measures to reduce the risk and is completing a Dam Safety Modification Study to find the best way to manage the risk long-term.

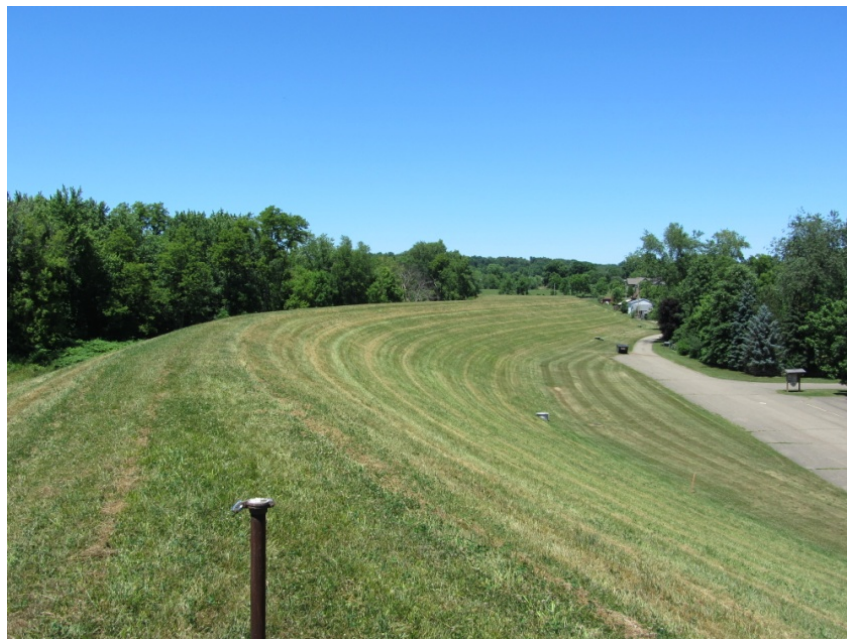
This is a 2012 photograph of the crest of the Ball Field side of Zoar Levee. When it was originally built, the crest of the levee was at elevation 919 feet. In the 1950s, Zoar Levee was raised to its current crest height of elevation 928.5 feet. At its highest point, Zoar Levee is approximately 45 feet high. The levee is approximately 3,893 feet long, or nearly 12 football fields.

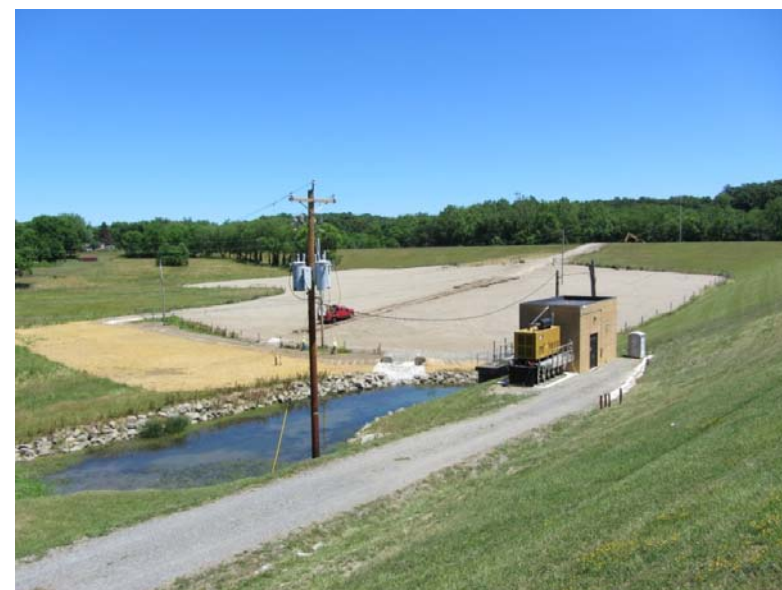
This is a 2012 photograph of the Rock Knoll side of Zoar Levee. When it was originally built, the Rock Knoll had two levees as a piece of high ground bisected it. However, following raising the levee in the 1950s, the embankment was merged. Also visible is the pump station in the foreground. It was also added in the 1950s. Recently the U.S. Army Corps of Engineers upgraded the pump so it can pump 45,000 gallons per minute. It also has a new diesel generator. A \$1.26 million dollar seepage blanket lines the interior of the Rock Knoll. It was placed in 2008 in response to significant under seepage that occurred.

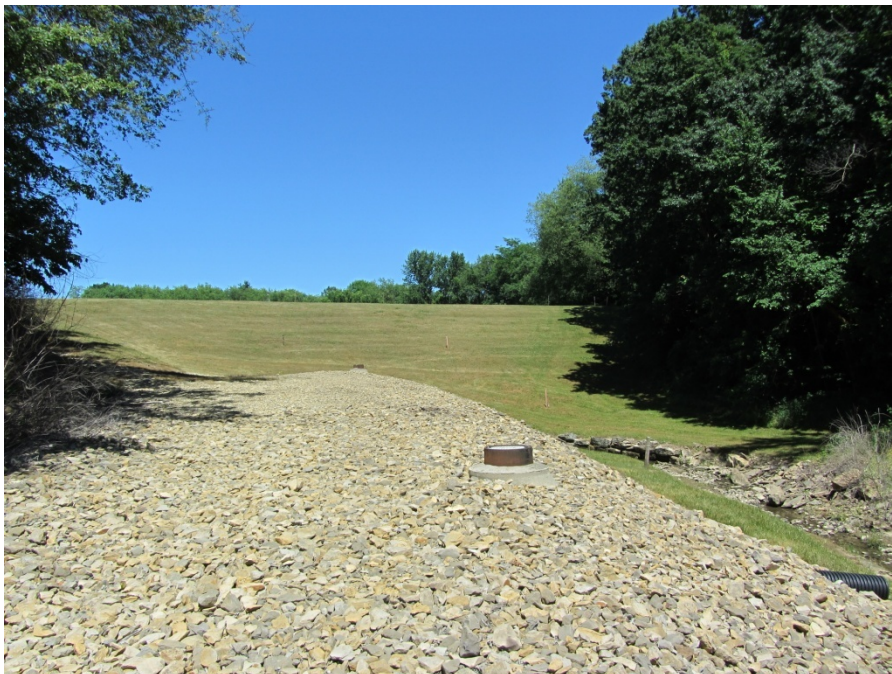
This is a 2012 photograph of the downstream face of Zoar Diversion Dam. Zoar Diversion Dam is located on Goose Run, about 1000 feet upstream from Zoar Levee. It is approximately 500 feet long and 35 feet high. In the foreground is a 1993 Seepage Blanket placed to help capture and control seepage that occurred through the abutment of the dam.

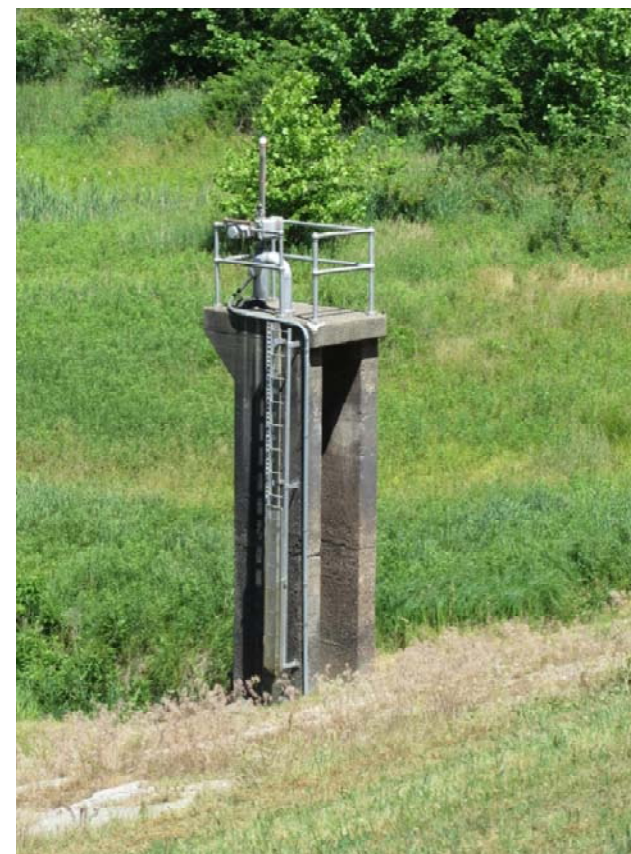
This is a 2012 photograph of the control tower for Zoar Diversion Dam. It is located on the upstream toe of the dam and it has a single sluice gate that can cover the 3-x-3 foot tunnel that carries Goose Run through the dam. Until the early 1990's, a permanent lake was impounded behind Zoar Diversion Dam. This lake partially drained itself through seepage on one of the abutments. Following some remedial actions, including the installation of the gravel blanket pictured above, it was recommended that the lake be permanently drained.

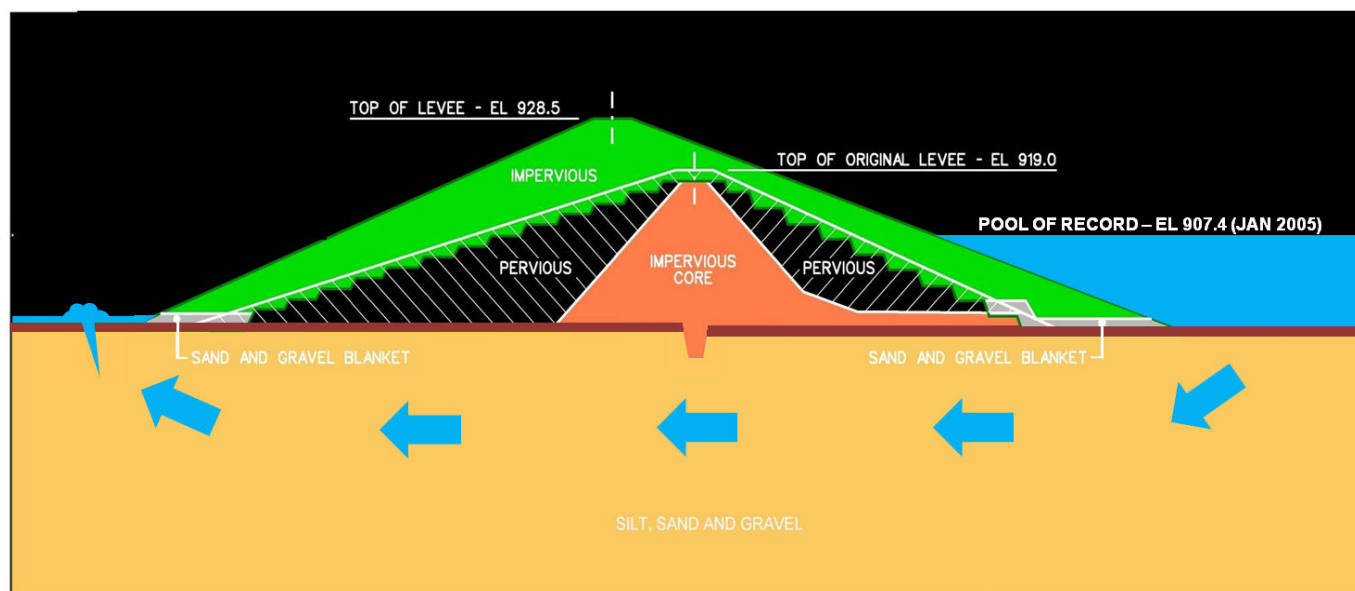
Below is a cross section of Zoar Levee demonstrating how water being impounded on the outside of the levee (right side) moves underneath the levee. This is called “under seepage”. Because Zoar Levee is founded on sands, gravels and fractured bedrock, this under seepage can lead to erosion of foundation materials if the right conditions exist.

The level of water displayed above (elevation 907.4 feet) corresponds to the highest amount of water Zoar Levee has had to hold back to date. This was the “Pool of Record” for Dover Dam. This event occurred in January of 2005 and caused under seepage. The U.S. Army Corps of Engineers, Huntington District was able to manage this seepage using sandbags.

In March of 2008, Dover Dam held a pool of water to elevation 904.6 feet which caused under seepage at Zoar Levee that led to much larger boils opening up. The largest boils occurred on the Rock Knoll, which continued to grow in size despite placing sandbags around them. In response to this event, the U.S. Army Corps of Engineers, Huntington District took emergency action by adding a large stone blanket that could help stabilize any eroding foundation material that might have been exiting the boils.

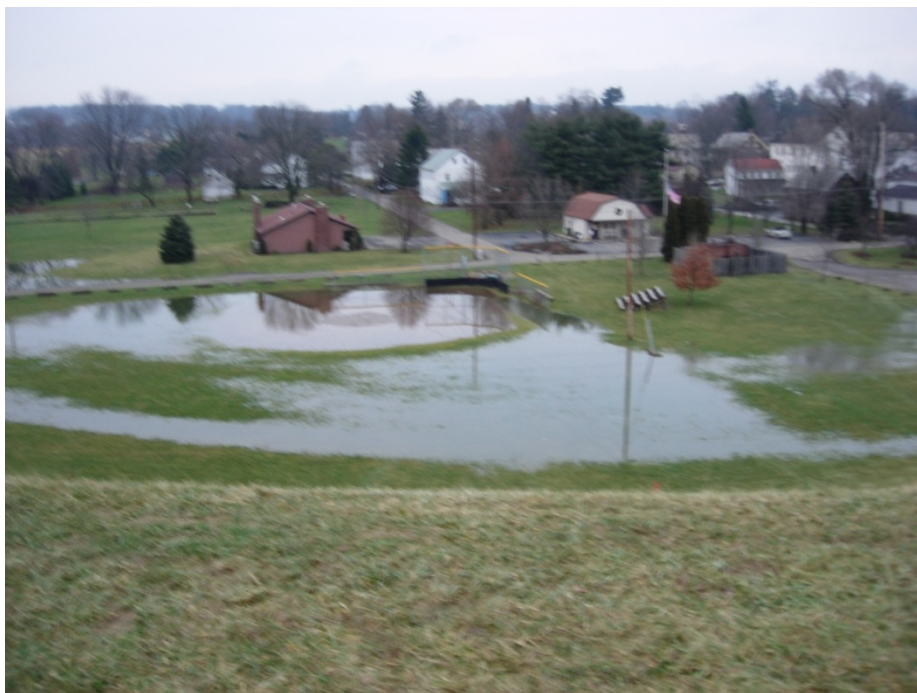
This a photograph of standing water on interior side of the Ball Field at Zoar Levee January 2005. This was evidence of under seepage occurring.

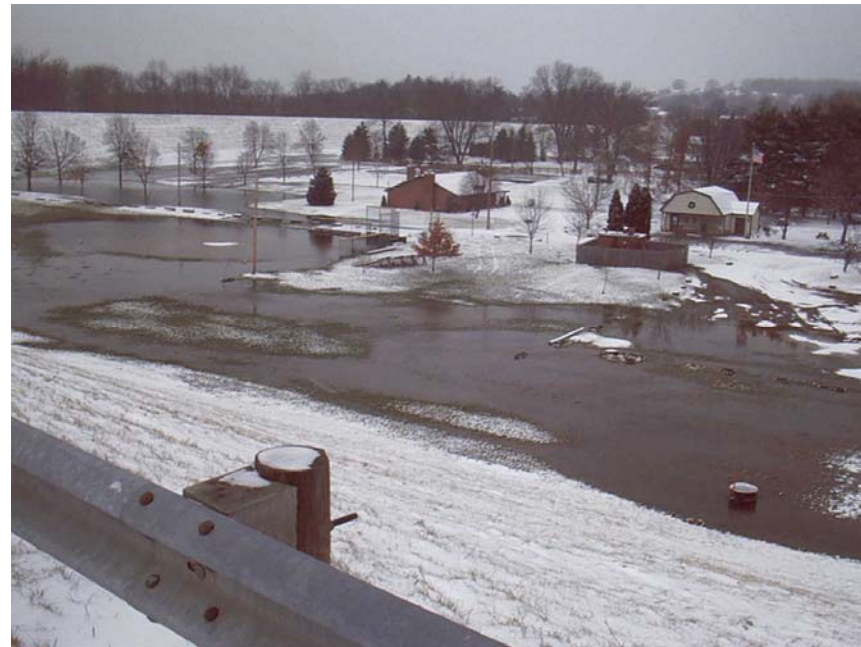
This is a photograph of standing water on interior side of the Ball Field at Zoar Levee January 2005. This was evidence of under seepage occurring.

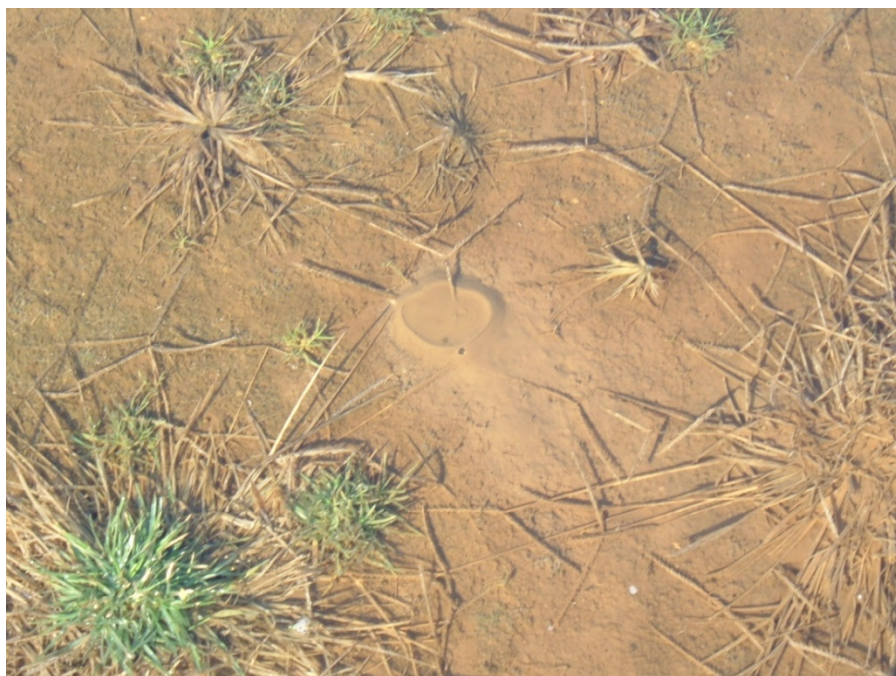
This is a picture of a small boil forming on the interior side of Zoar Levee in January of 2005. This is called a “pin boil”. These pin boils showed that seeping water was moving a small amount of soil.

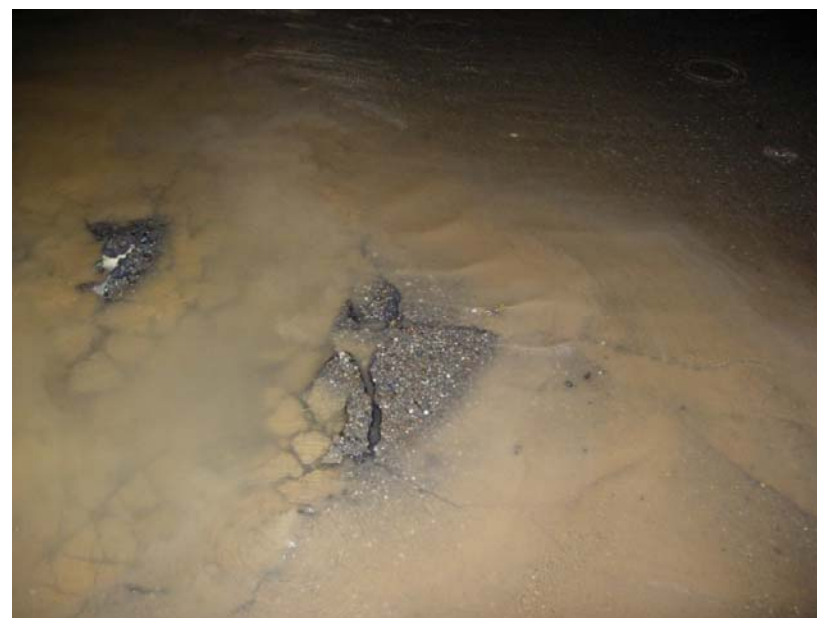
Portions of the Ball Field side at Zoar Levee are paved with asphalt for parking. This is a picture of that pavement failing due saturated soil conditions and vehicular traffic in 2005.

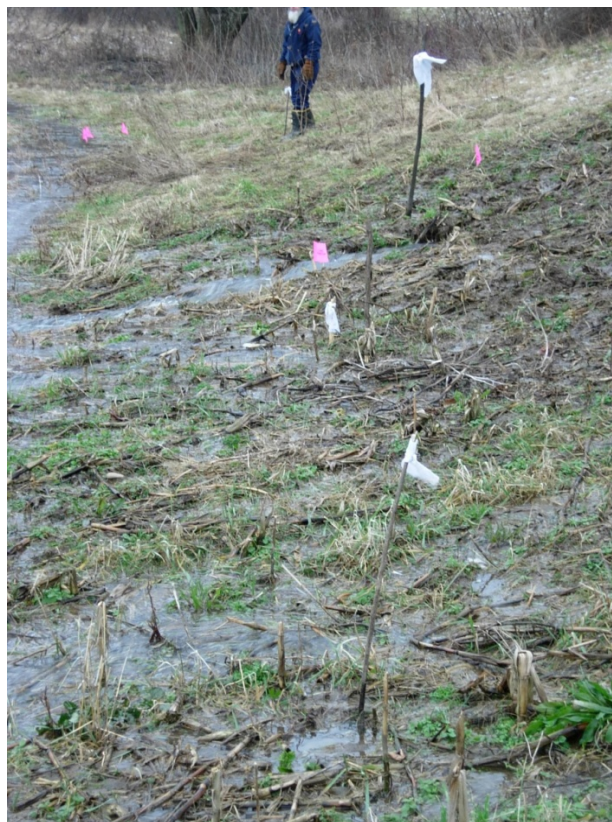
This is a photograph of water seeping on the interior side of the Rock Knoll at Zoar Levee in January 2005. At this location water exited directly from the ground in large volumes.

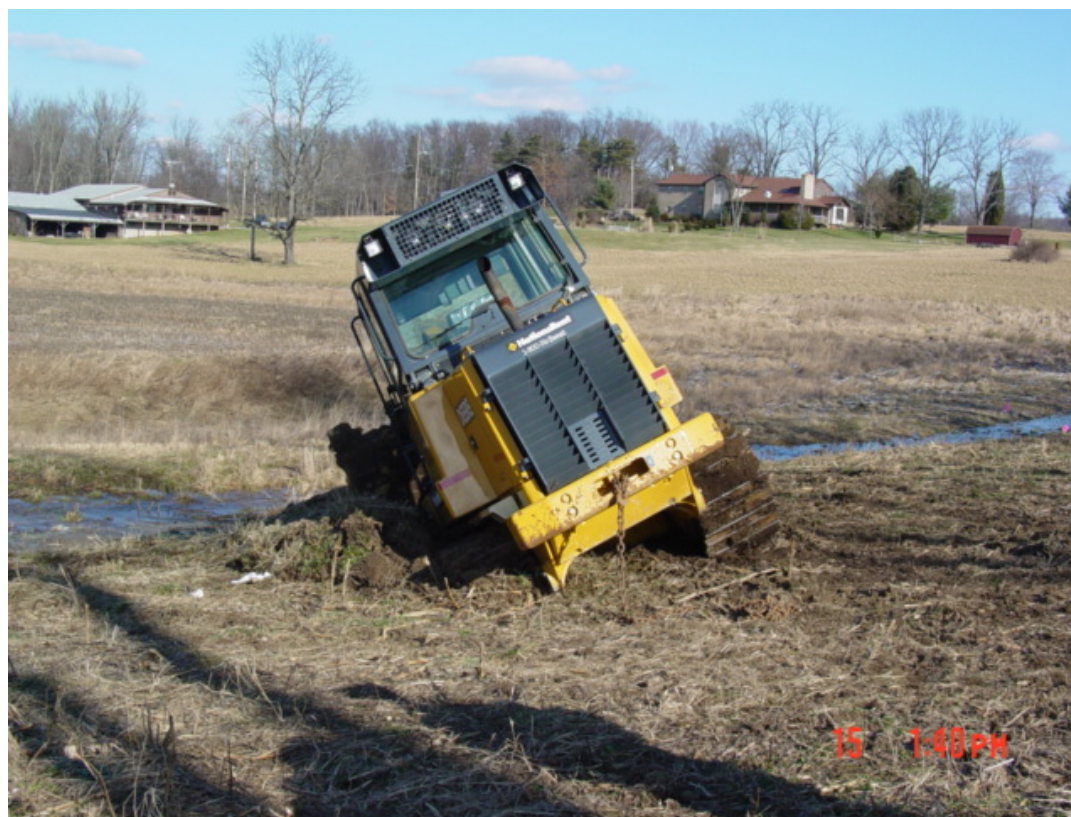
This is a photograph of mechanical equipment stuck in the saturated ground on the interior side of the Rock Knoll at Zoar Levee in January 2005.

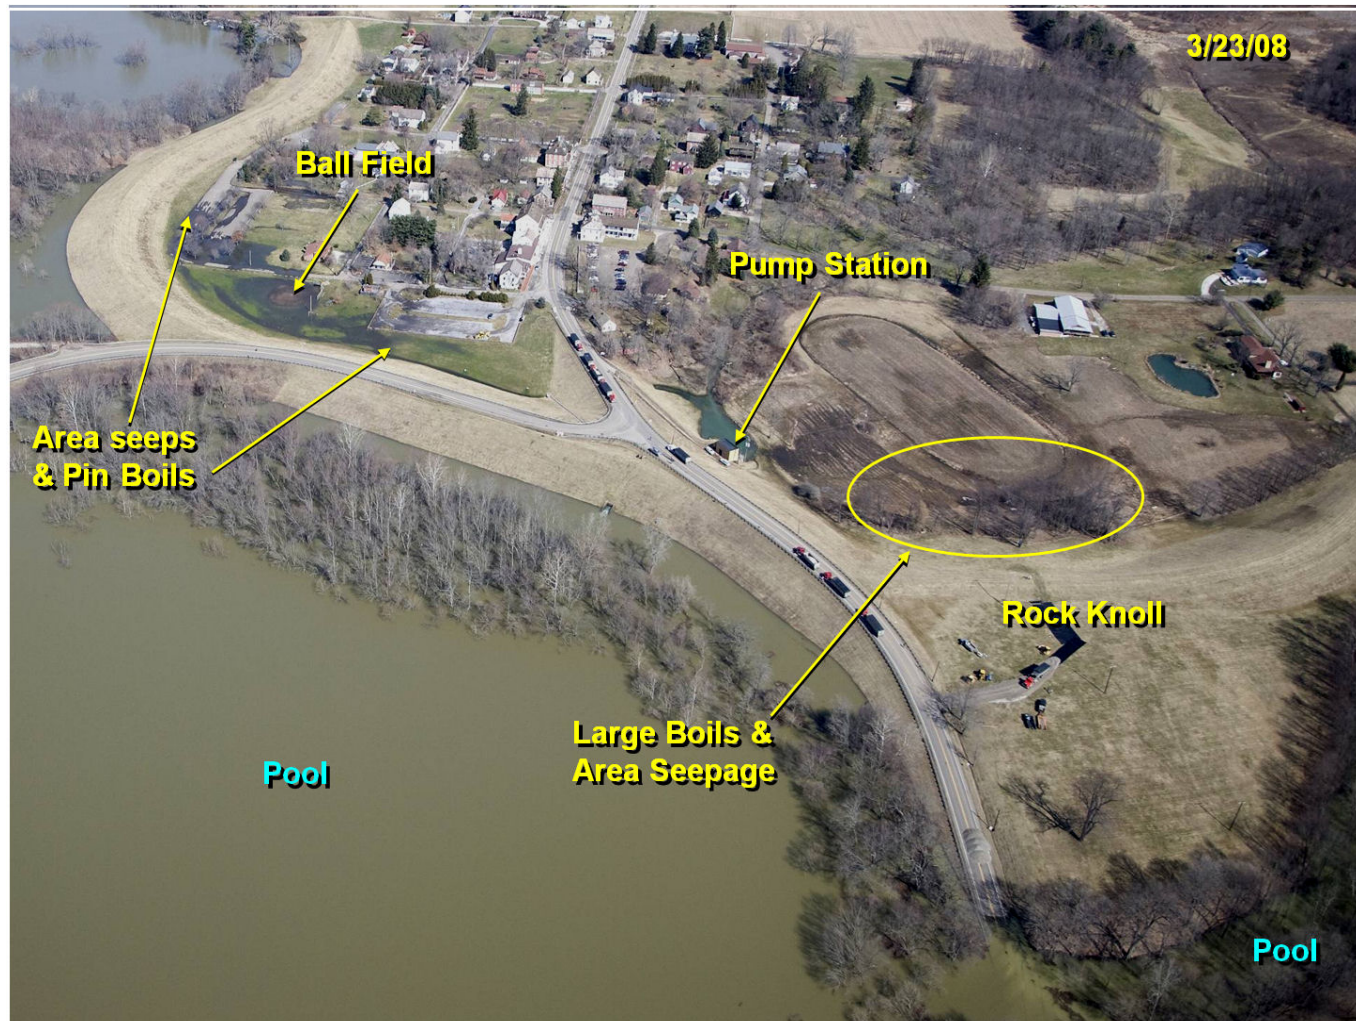
This is an oblique view of Zoar Levee graphically demonstrating the locations of area seepage, pin boils, and large boils on the interior of Zoar Levee in March of 2008. This photograph was taken at the peak elevation (904.6 feet) of the Tuscarawas River during this event.

As noted, the most significant problems occurred along the Rock Knoll at the same location and elevation where water was seen significantly seeping in January 2005.

The March 2008 event resulted in a pool of water that was approximately 3

feet lower than what occurred in January of 2005. The performance of Zoar Levee decreased significantly and the U.S. Army Corps of Engineers, Huntington District took emergency action.

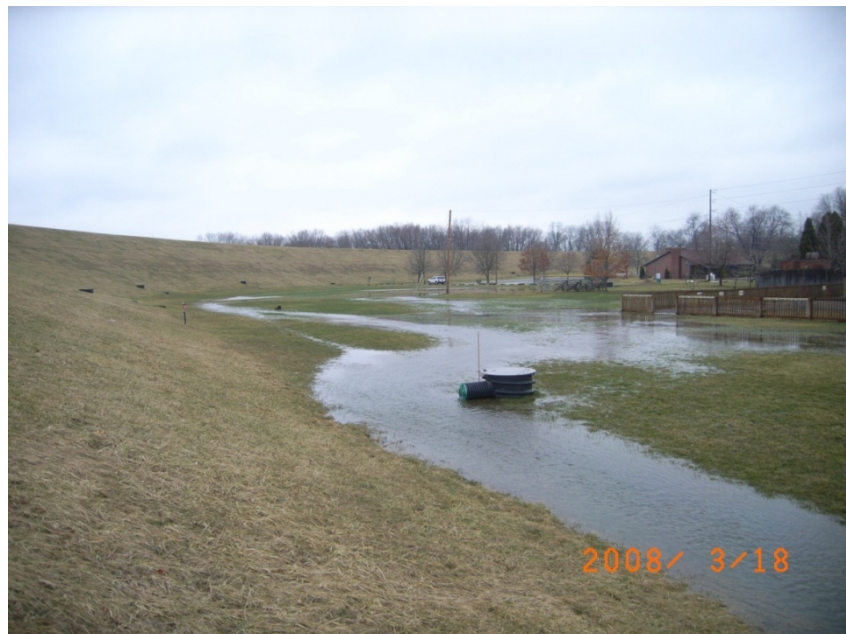
This is a photograph of standing water on interior side of the Ball Field at Zoar Levee March 2008. This was evidence of under seepage occurring. This condition was very similar to that observed in January of 2005.

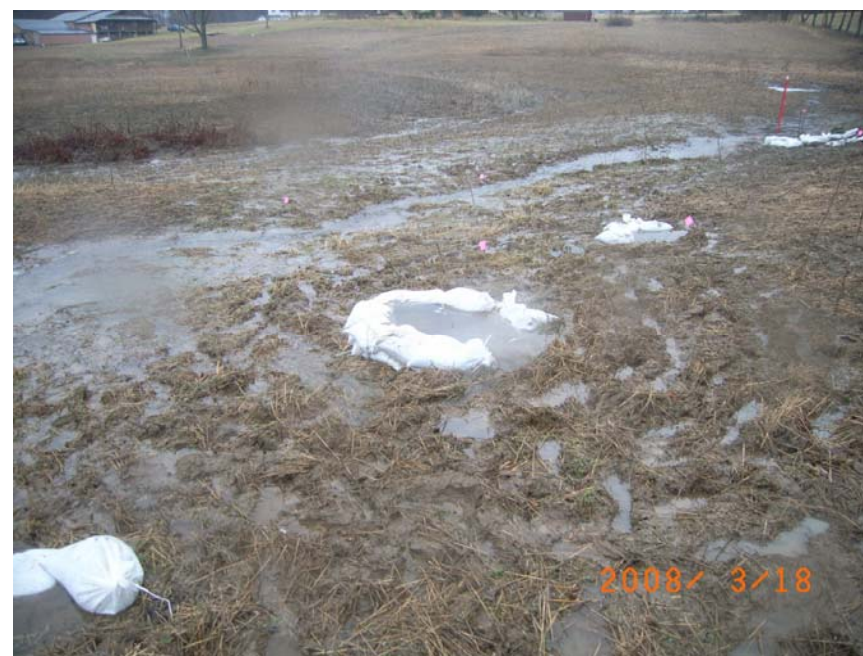
This is a photograph of water seeping on the interior side of the Rock Knoll at Zoar Levee in March 2008. Like in January 2005, water exited directly from the ground at this location in high volumes. Unlike January 2005, large boils formed in 2008. These boils are marked by the white rings of sandbags. These sandbag rings are deployed to stabilize the boils and keep them from increasing in size.

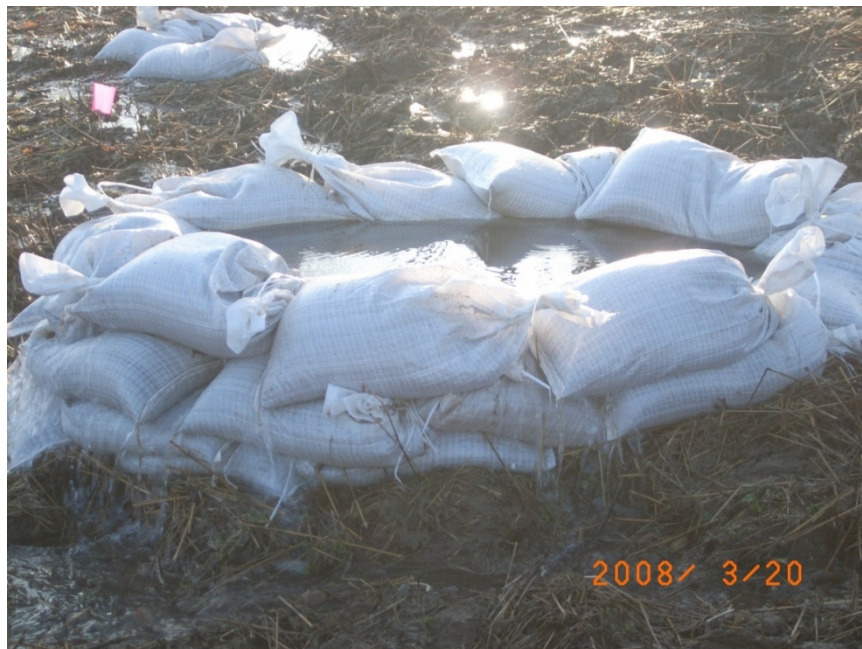
This is a photograph of another boil on the interior side of the Rock Knoll at Zoar Levee in March 2008. The amount of sandbagging employed was increased as boils continued to grow in diameter.

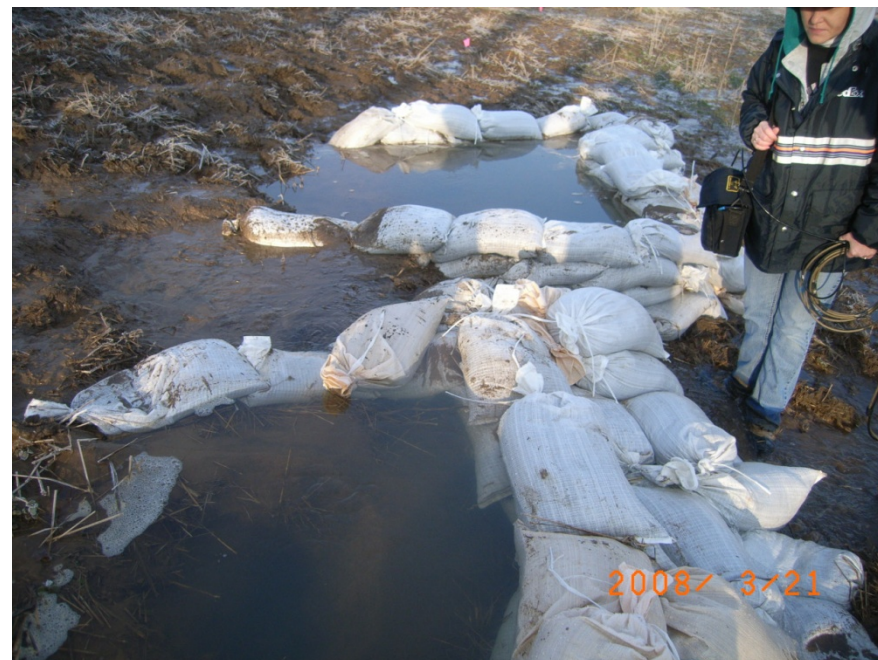
This is a photograph of boils on the interior side of the Rock Knoll at Zoar Levee in March 2008. Despite attempts to control the growing size of boils with sandbag rings, boils continued to expand rapidly, eventually coalescing into one another, forming a large seepage exit point.

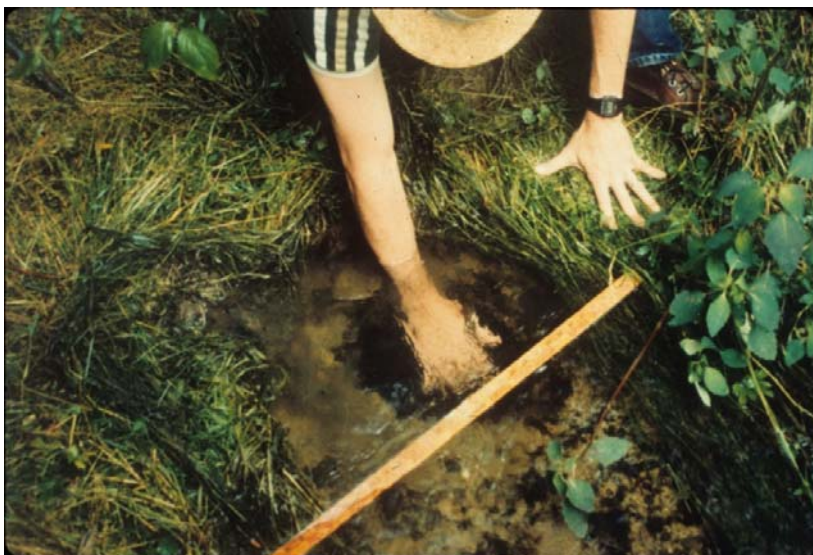
This is a photograph of a boil located downstream of Zoar Diversion Dam that was resulting from the seepage. This seepage was traveling through the bedrock that the diversion dam abuts. This is referred to as “abutment seepage”. This abutment seepage partially drained the permanent impoundment from elevation 916’ to elevation 906’.

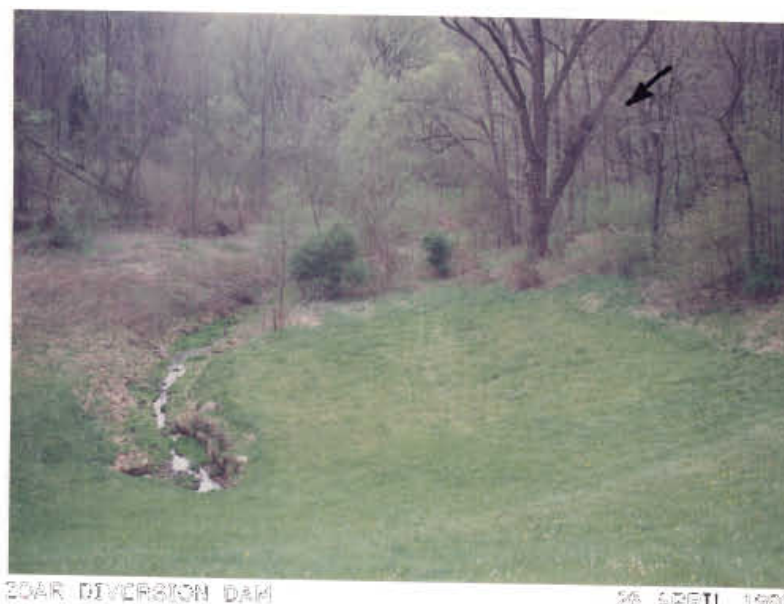
This is a photograph from the crest of the Zoar Diversion Dam looking downstream. Goose Run can be seen exiting at the toe of the dam. The black arrow is highlighting the location where seepage was occurring.
